**TRLIA**

**Yuba River  
Phase IV  
Levee Repairs**

**Caltrans Detention Basin  
Reclamation District 784  
Yuba River, south levee**

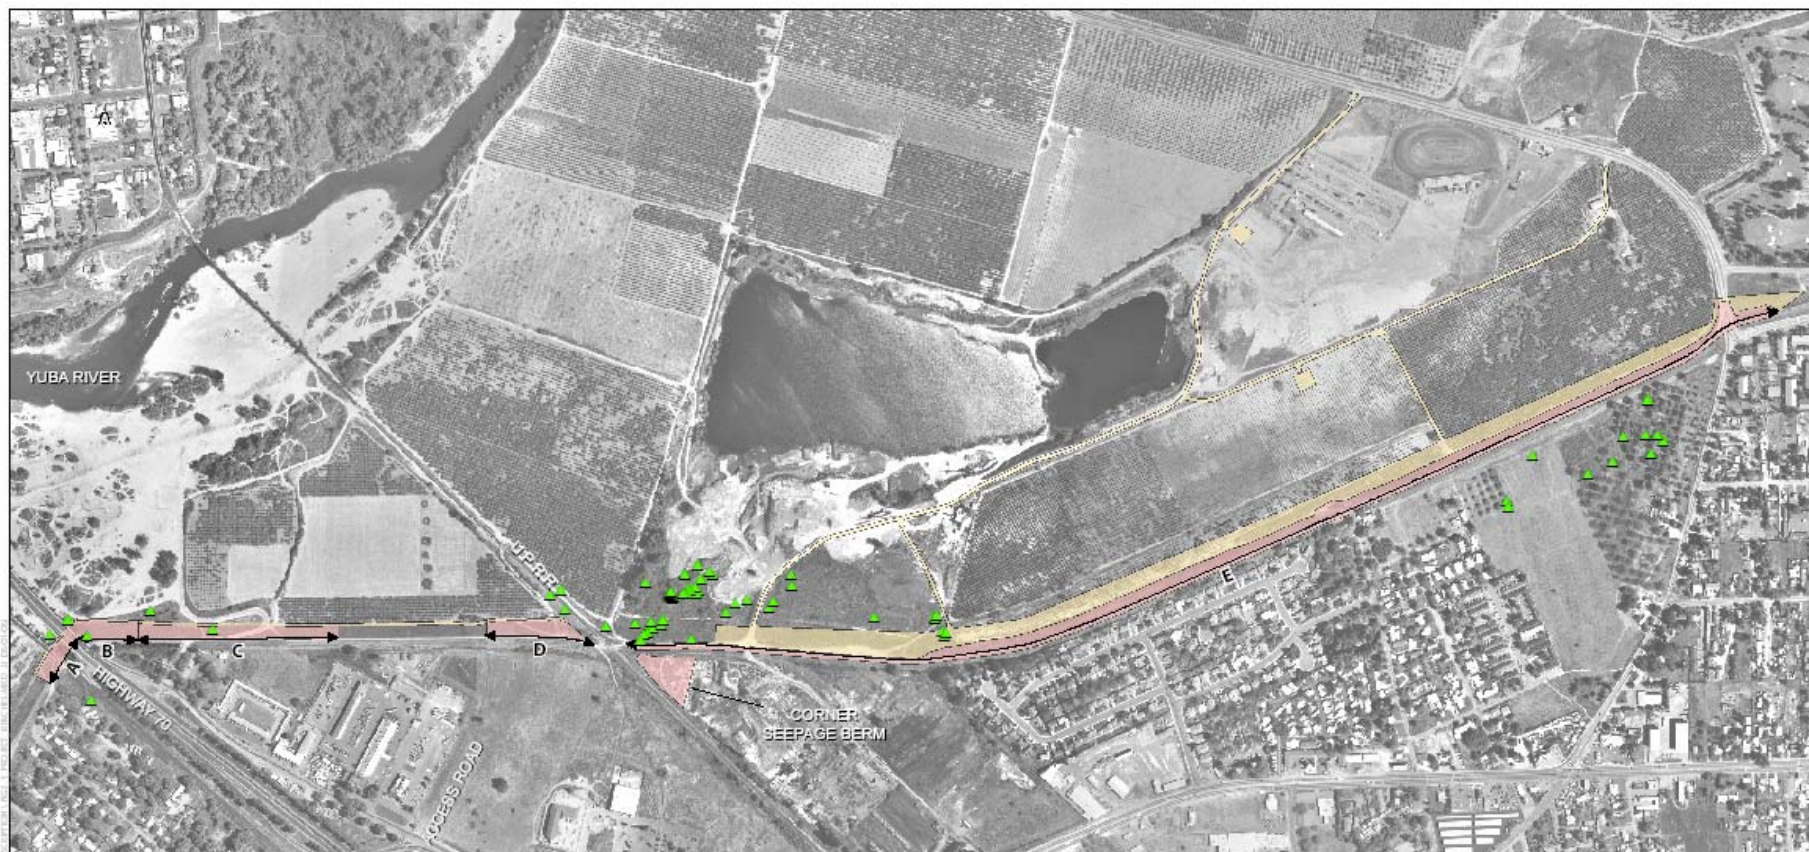
Reach	Issue	Levee Treatment
A	Erosion	Levee Waterside Slope Erosion Protection
B	Freeboard	Raise Crown 0.4 feet by Full Levee Raise (Waterside)
C	Oversteepened Slope	Flatten Waterside Slope to 3:1
D	Freeboard	Raise Crown 0.4 feet by Full Levee Raise (Waterside)
E	Under-Seepage and Through-Seepage	Slurry Cutoff Wall 80 feet deep, Raise Crown 0.4 feet by Full Levee Raise (Waterside), and Corner Seepage Berm
